1971-76 GM FULL SIZE (*Scissor Top*) CONVERTIBLE TOP MECHANISM

SCISSOR TOP ELECTRICAL SYSTEM

SCISSOR TOP RELAY BENCH TEST

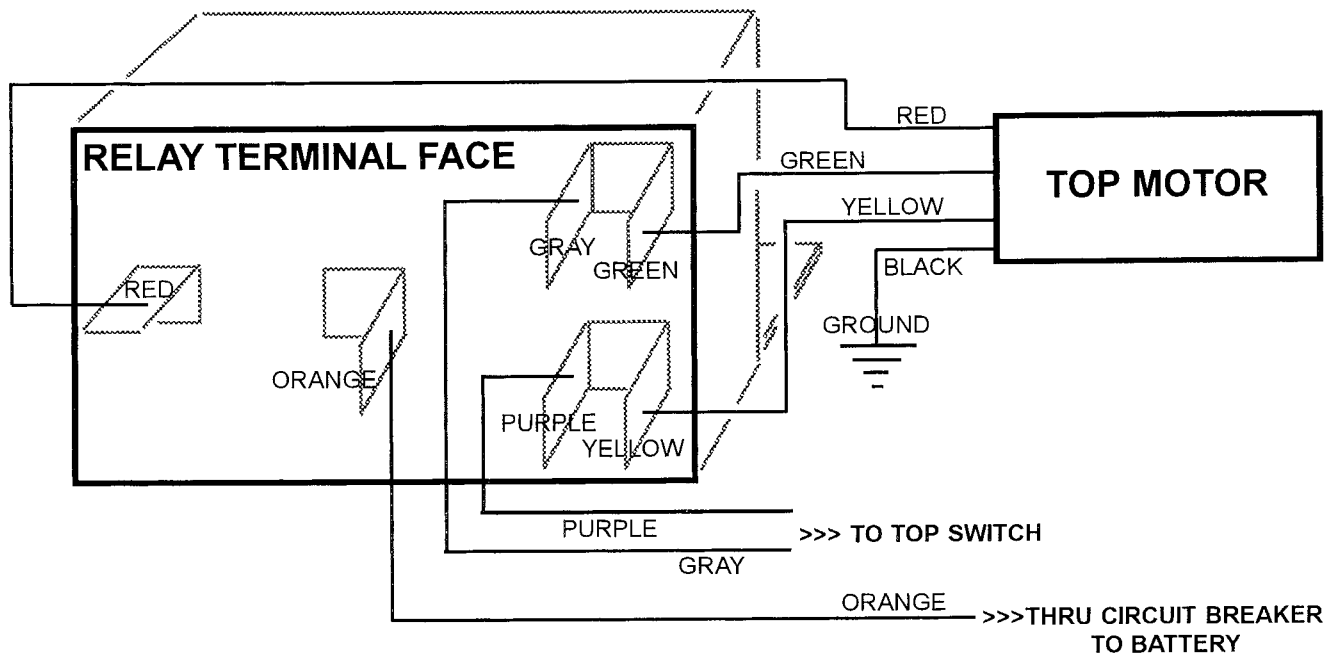
IN-CAR TOP SWITCH TEST - Turn ignition key to "ON", then pull off 3 wire connector (gray, purple & orange) from the center of relay.

STEP 1 - A test light should show constant current on orange wire. If not, check feed from battery.

STEP 2 - With top switch pushed in one direction, test light should show current on gray wire.

With top switch pushed in other direction, test light should show current on purple wire.

IN-CAR RELAY TEST - If top switch has tested good (see above), proceed with relay test with ignition key "ON", and all car wires re-attached.

Use test light to verify constant current at middle terminal (orange).

STEP 1 - Push top switch in one direction: test light should show current to yellow & red terminals.

STEP 2 - Push top switch in other direction: test light should show current to green & red terminals.
