1971-76 GM FULL SIZE (*Scissor Top*) CONVERTIBLE TOP MECHANISM

SCISSOR TOP RELAY BENCH TEST

SCISSOR TOP ELECTRICAL SYSTEM

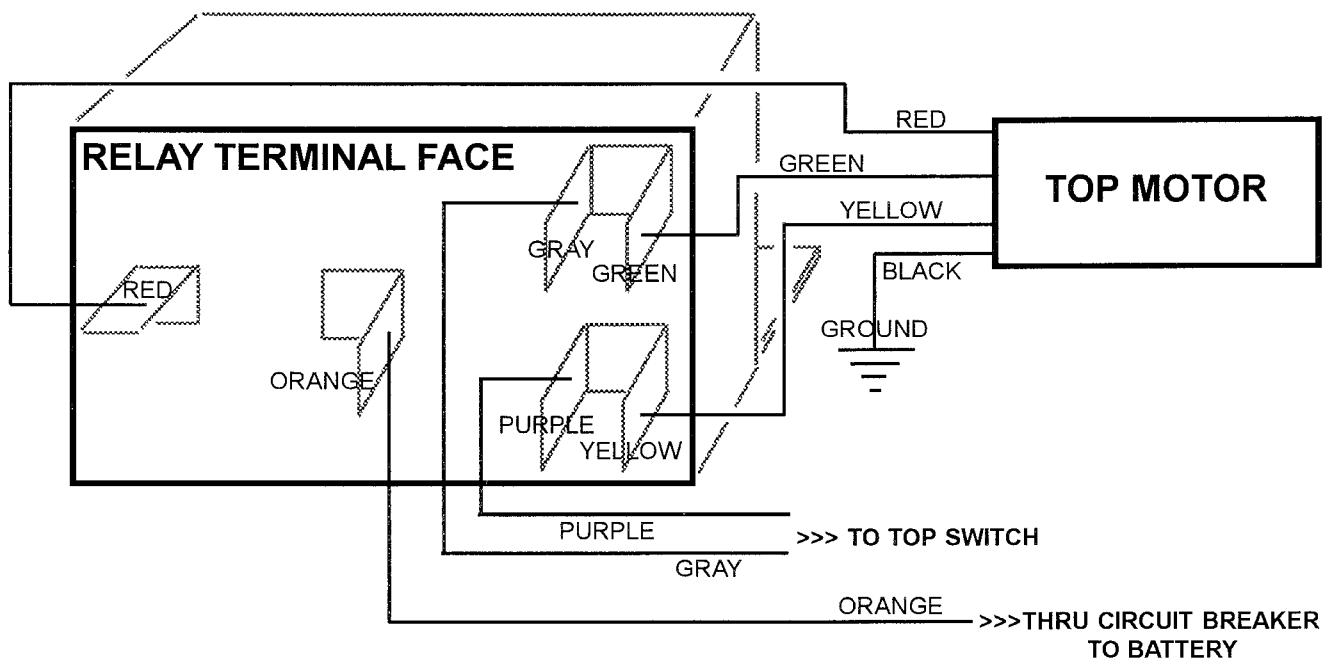
IN-CAR TOP SWITCH TEST - Turn ignition key to "ON", then pull off 3 wire connector (gray, purple & orange) from the center of relay.

IN-CAR RELAY TEST - If top switch has tested good (see above), proceed with relay test with ignition key "ON", and all car wires re-attached.
Use test light to verify constant current at middle terminal (orange).

STEP 1 - Push top switch in one direction: test light should show current to yellow & red terminals.

STEP 2 - Push top switch in other direction: test light should show current to green & red terminals.
